**DEPARTMENT OF TRANSPORTATION**

Contract #: 04-0120F4Cty: SF/ALA Rte: 80 PM: 13.2/13.9File #: 1.28**WELDING INSPECTION REPORT****Resident Engineer:**Siegenthaler, Peter**Address:** 333 Burma Road**City:** Oakland, CA 94607**Report No:** WIR-024264**Date Inspected:** 02-Jun-2011**Project Name:** SAS Superstructure**OSM Arrival Time:** 700**Prime Contractor:** American Bridge/Fluor Enterprises, a JV**OSM Departure Time:** 1530**Contractor:** American Bridge/Fluor Enterprises, a JV**Location:** Job Site**CWI Name:** Pat Swain**CWI Present:** Yes No**Inspected CWI report:** Yes No N/A**Rod Oven in Use:** Yes No N/A**Electrode to specification:** Yes No N/A**Weld Procedures Followed:** Yes No N/A**Qualified Welders:** Yes No N/A**Verified Joint Fit-up:** Yes No N/A**Approved Drawings:** Yes No N/A**Approved WPS:** Yes No N/A**Delayed / Cancelled:** Yes No N/A**Bridge No:** 34-0006**Component:** Tower**Summary of Items Observed:**

## WELDING INSPECTION REPORT

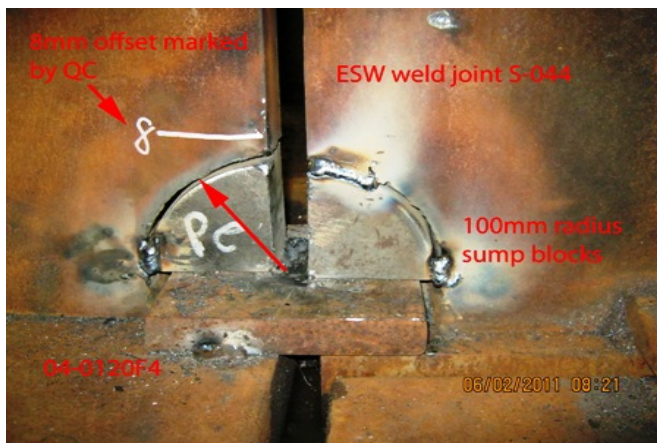
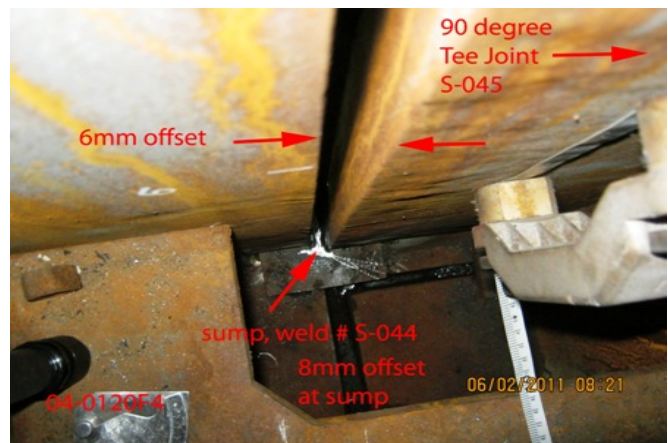
This QA Inspector observed as ABF welding personnel Jeremy Dolman (#5042) tack welded the sump blocks into position from the center section of the tower. This QA Inspector randomly observed a hand held torch was used for preheating to an approximately temperature of 200°F, verified by QC Inspector Steve McConnell. This QA Inspector observed the Shielded Metal Arc Welding (SMAW) process was used for tack welding and verified the following parameters, 125 amperes using a 3.2 mm diameter E7018H4R electrode. The welding observed appeared to comply with Welding Procedure Specification (WPS) ABF-WPS-D15-F1200A Rev-2, see photo below..
